**ALASKA DEPARTMENT OF ENVIRONMENTAL CONSERVATION**  
**Division of Spill Prevention and Response**  
**Prevention and Emergency Response Program**  
**SITUATION REPORT**

## *Kulluk* Tow Incident

**SITREP #:** 13 and Final

**SPILL #:** 12249936201

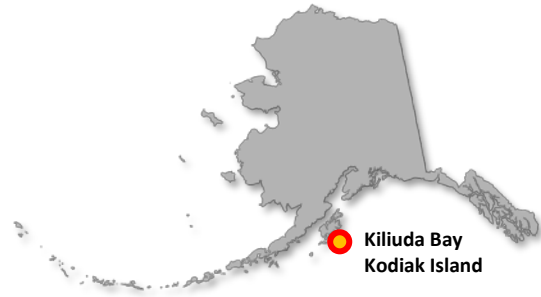
**Response Action:** The CDU *Kulluk* remains safely anchored in Kiliuda Bay at its assessment position. In addition to being anchored, the CDU *Kulluk* is also tethered to the M/V *Lauren Foss* and the M/V *Ocean Wave*. The vessel has been inspected by Det Norske Veritas and the Coast Guard for damage. It has been determined by these inspections that in its current condition the *Kulluk* does not pose a threat to the environment and can be safely relocated to Dutch Harbor, Alaska.
