**ALASKA DEPARTMENT OF ENVIRONMENTAL CONSERVATION**  
Division of Spill Prevention and Response  
Prevention, Preparedness, and Response Program

***SITUATION REPORT***

**Beaver Joint Utilities Fuel Transfer Release**

**SITREP # 2 & Final**

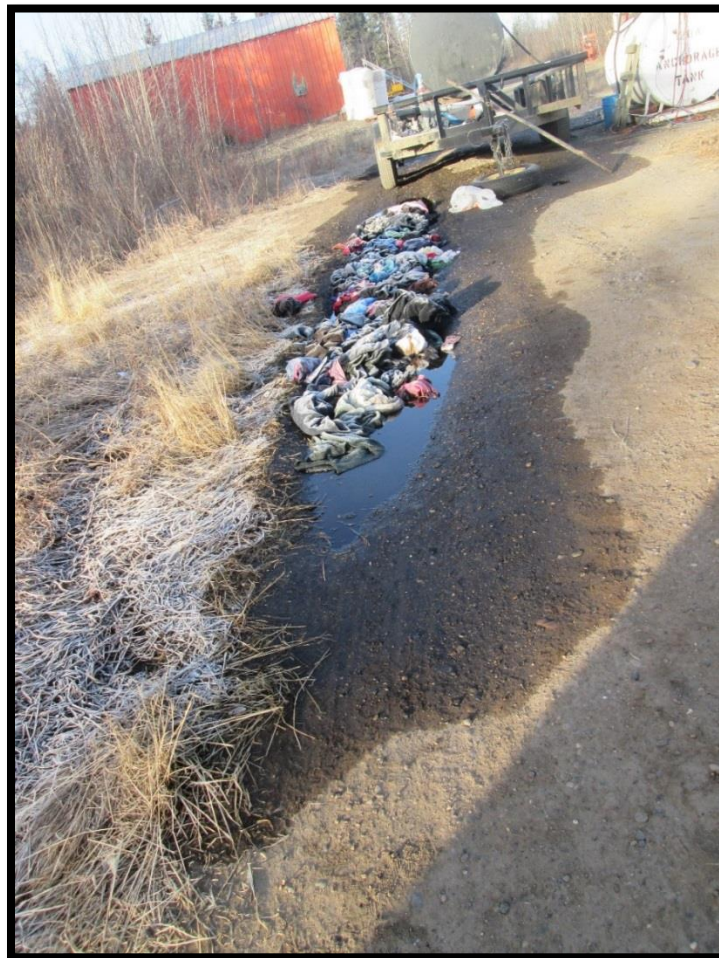
**CAUSE OF SPILL:** During fuel transfer operations between a mobile and stationary AST the fuel transfer hose disconnected, which allowed fuel to release onto the ground.

Spill site with sorbent material during the morning of October 19, 2016. (Photo/BJU)

**RESPONSE ACTION:** Initial response actions were initiated immediately upon discovery of the disconnected hose. When the driver observed the release, he gathered old clothing and used it to absorb the spilled fuel. Some remaining free product was observed during the inspection on morning of October 19<sup>th</sup>. Recoverable fuel was then removed by absorbent pads which were found after the initial deployment of old clothing. **BJU response personnel conducted soil removal activities between October 20-28, 2016 to remove the most severely contaminated soil from the site.**

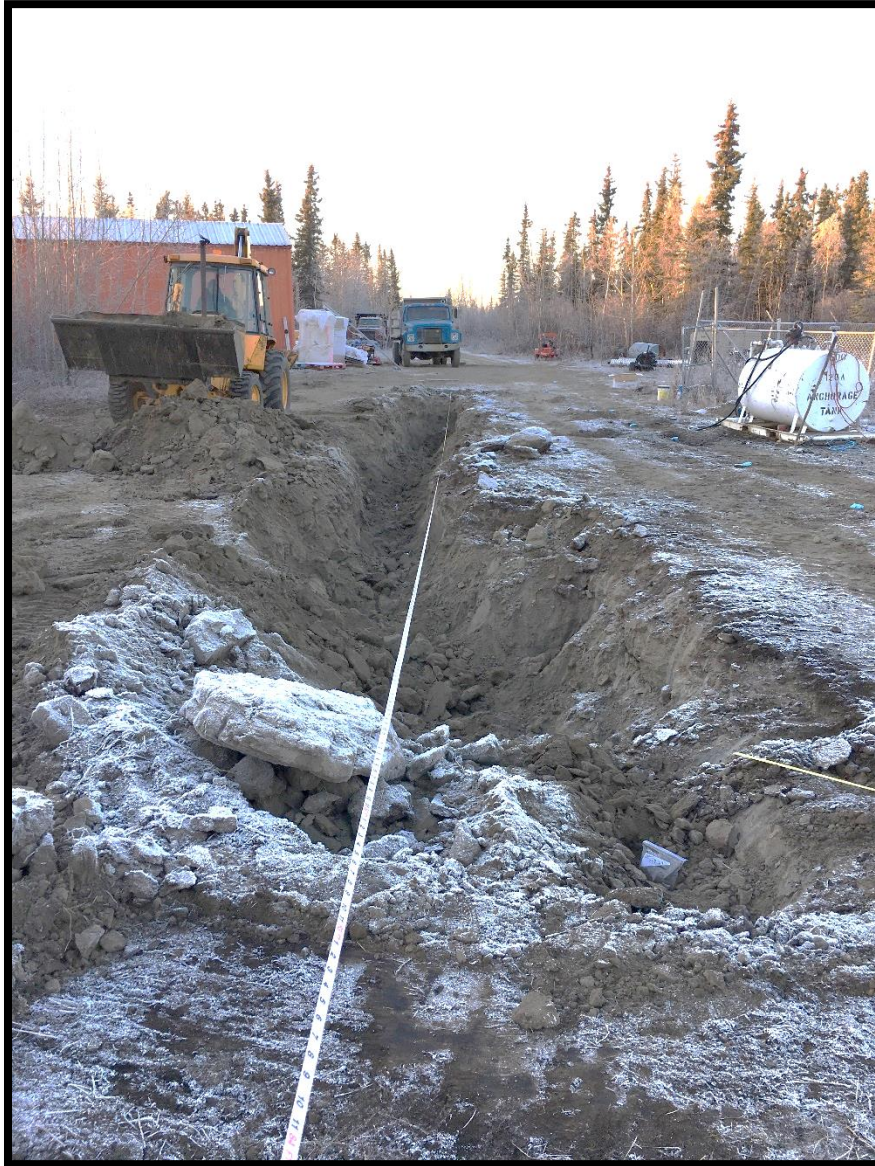
**FUTURE PLANS AND RECOMMENDATIONS:** **Screening and laboratory sample results from the excavation show that there is still significant contamination remaining at five feet below ground surface. Due to the cold**

Spill site on October 28, 2016 after removal of saturated soils. (Photo/ADEC)

temperatures and frozen soils, additional soil removal activities will have to wait until next spring or summer. The department will continue coordinating cleanup activities with BJU to ensure that the released product does not pose a threat to human health or the environment.
