ALASKA DEPARTMENT OF ENVIRONMENTAL CONSERVATION  
Division of Spill Prevention and Response  
Prevention Preparedness and Response Program  
***SITUATION REPORT (SITREP)***

## **MP317 Richardson Hwy US Army Tanker Rollover**

**SITREP #:** 3

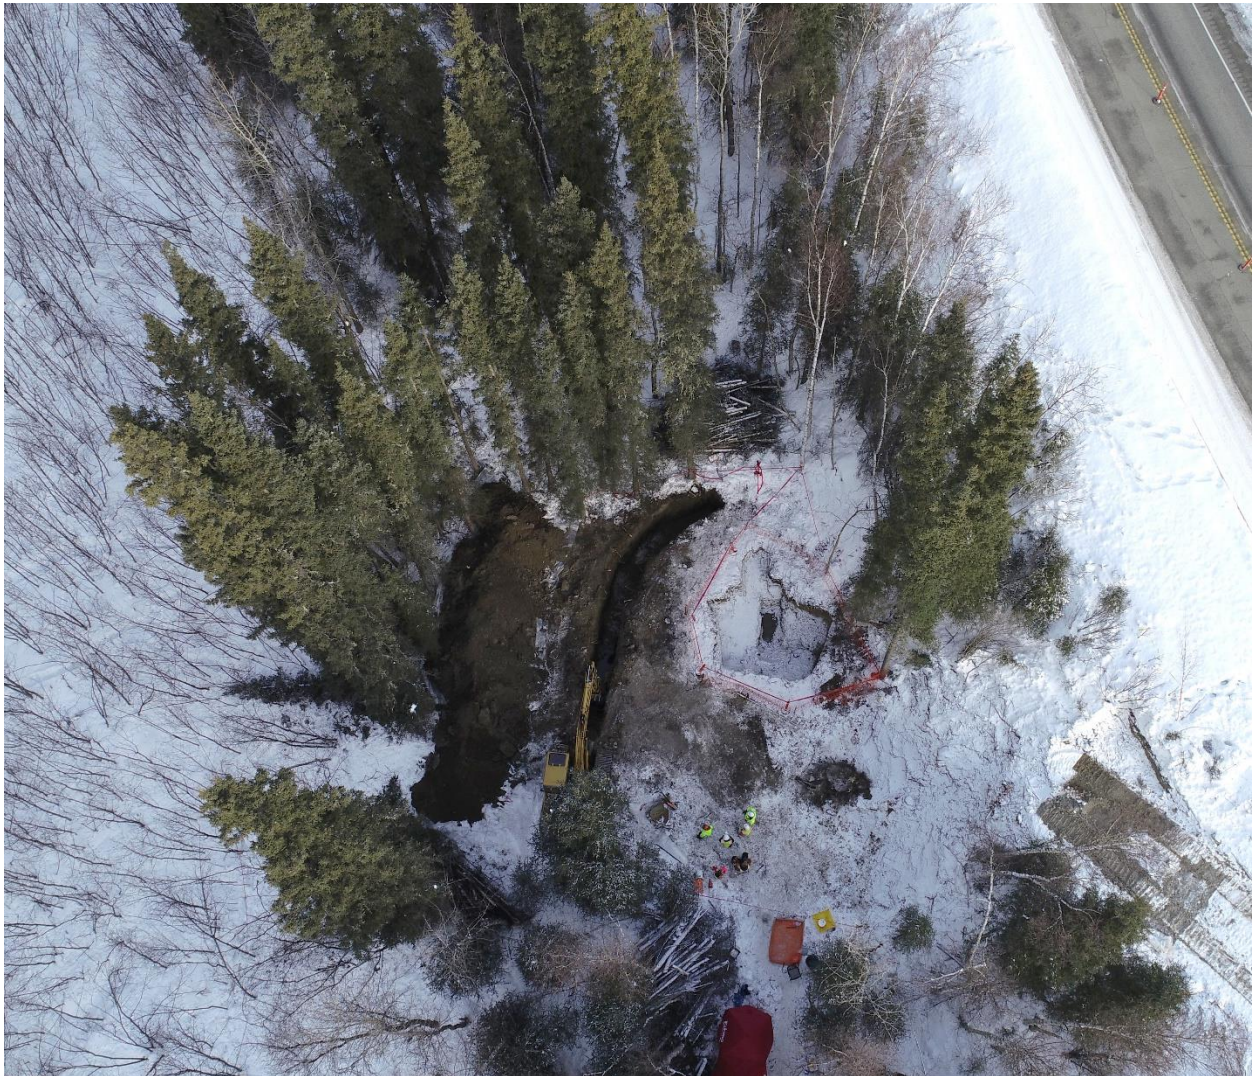
Aerial view of spill site on March 16 2018, facing down. The area known contain affected soils and groundwater is located inside the red exclusion tape. Interception tactics had been completed at this time, and clean soils stockpiled adjacent to the trench (Photo/ADNR).

On March 14, while excavating affected soils from the release area, groundwater was discovered at seven feet below ground surface. A petroleum based sheen was observed on the water surface, but not in any recoverable amount. A groundwater sample, used to determine concentrations of petroleum potentially dissolved in to the water column, was collected from the affected media on this date and will be shipped to an ADEC approved laboratory for analysis. A test pit (used to delineate potentially affected subsurface soils and groundwater) was excavated approximately 25 feet downgradient from the initially identified release area on March 15, but no contaminated soil or groundwater was detected. On March 16, a trench was excavated approximately 25 feet downgradient of the initial excavation in an attempt to intercept any product migrating through the subsurface. No additional contamination was discovered on this date.
