SITUATION REPORT (SITREP)

Selawik Water Treatment Plant Diesel Overfill

SITREP # 3

SPILL #: 20389933001

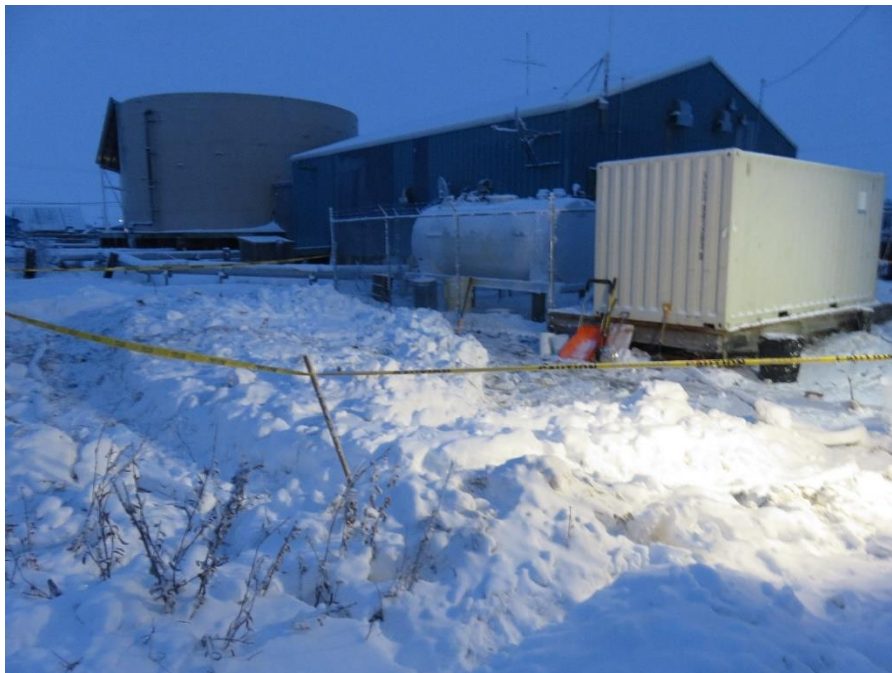
A diesel fuel transfer from the Consolidated Tank Farm Tank to the WTP "day tank" was left unattended on November 25, 2020 from 2:25 p.m. until the WTP operator was notified the tank outside the WTP was overflowing and closed the valve at approximately 10:00 p.m.

Spill site at the WTP day tank (Photo credit: Sonny Berry, USFWS)

After initial notifications, a response crew from Selawik removed free product using a pump and sorbent materials on November 26, 2020. Recovery work consisted of a crew shoveling contaminated snow into

supersacks, bulk containers, and recovering free product by wringing out absorbents. The extent of the spill has been delineated and estimated to be approximately 1,800 square feet, including an additional 300 square feet of contamination discovered December 9, 2020. The additional 300 square feet of contamination was found beneath a boardwalk, adjacent to the spill site, and approximately 10 feet from the WTP building air intake. The City of Selawik reports that contaminated snow removal was completed at the spill site on December 11, 2020, and that approximately 750 gallons of diesel was recovered, including 400 gallons of free product. The City has moved all recovered contaminated snow and oily waste to a lined containment cell built on city property outside of town for storage until it can be treated for disposal. Contamination remaining in the soil has been covered until it can be addressed for clean up in the spring. The spill location is approximately 610 feet from the Selawik River and less than 100 feet from the Selawik Davis Ramoth Memorial School. No injuries have been reported.

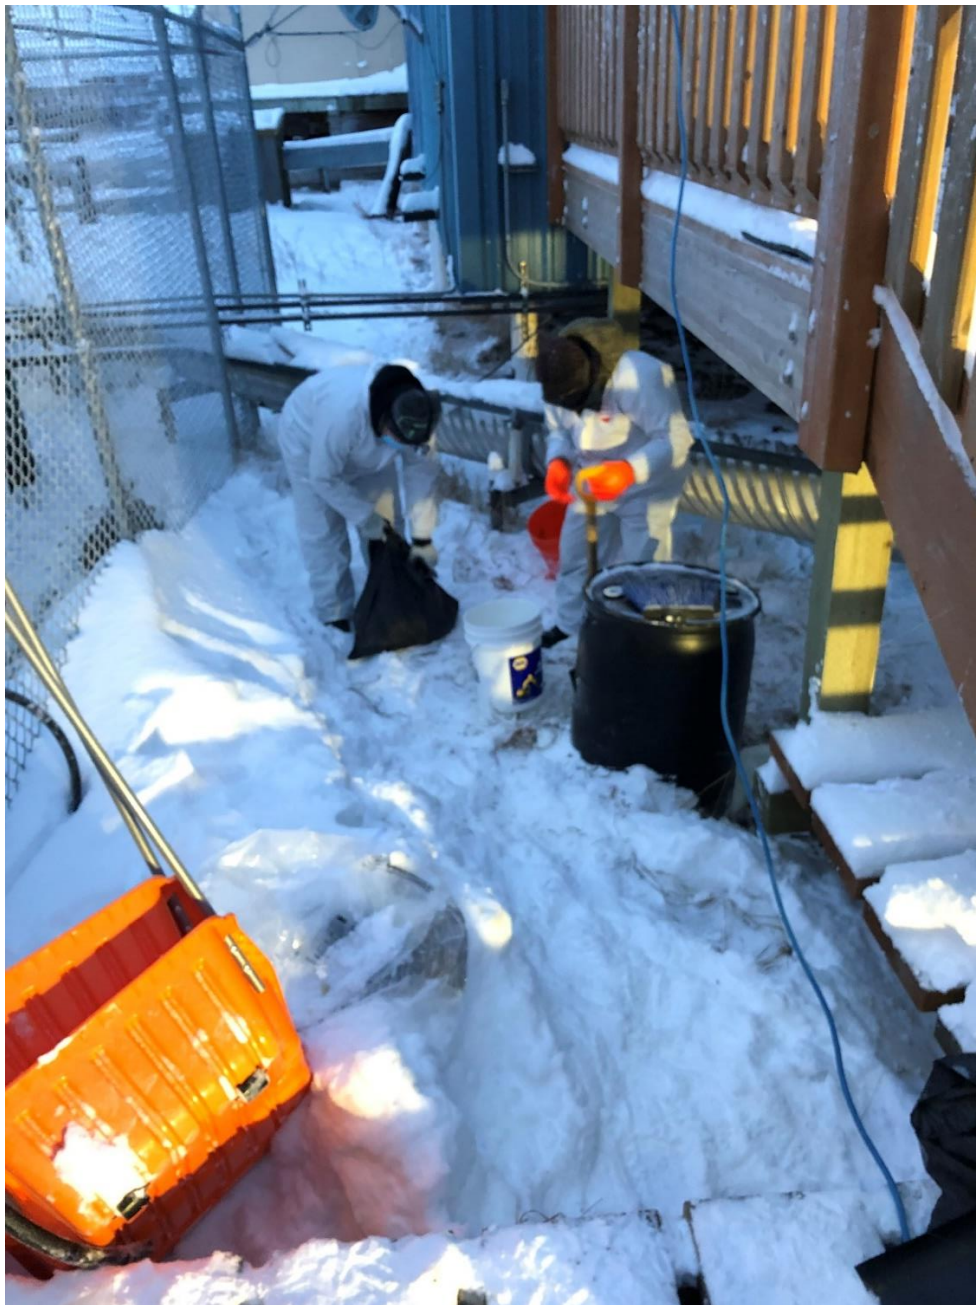
Response crew members recover contaminated snow December 9, 2020 (Photo credit: USCG)
