**ALASKA DEPARTMENT OF ENVIRONMENTAL CONSERVATION**  
**Division of Spill Prevention and Response**  
**Prevention and Emergency Response Program**

**SITUATION REPORT**

**INCIDENT NAME:** EAFB Product Recovery Tank Spill      **SITREP #:** 2

**LOCATION:** West Ramp Pumphouse Building 13196, EAFB.

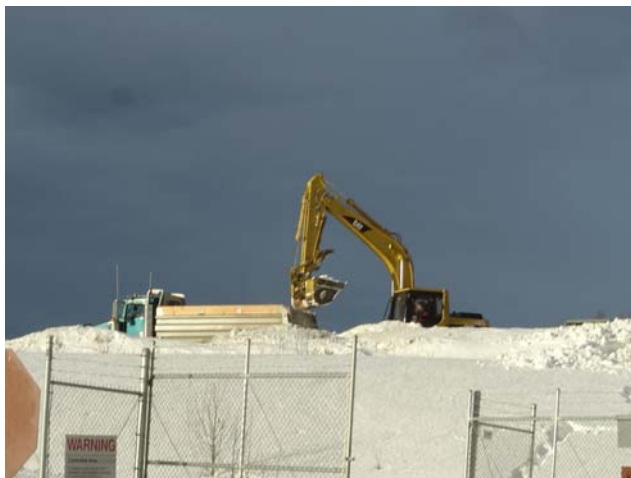
Fuel contaminated snow being loaded into a dump truck for transport to disposal site.

**RESPONSE ACTION:** On February 13, ADEC responders from PERP and IPPP met with EAFB Civil Engineering spill team and their contractor. The free product recovery and mechanical removal of contaminated snow will be completed by today. EAFB and their environmental contractor, Weston Solutions, estimated a total of 1415 gallons of free product has been recovered from the spill site. Weston Solutions estimated 350 cubic yards of contaminated snow has been transported to Emerald Services of Alaska (Emerald) facility for processing.

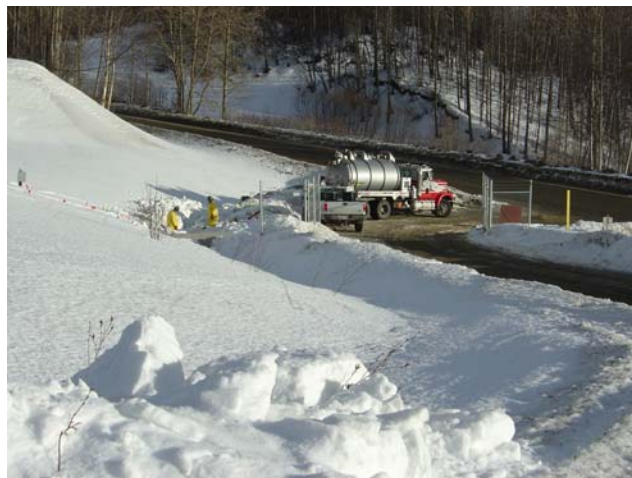
Response worker's using a vacuum truck to recover fuel from a ditch at the lower end of the spill area.
