ALASKA DEPARTMENT OF ENVIRONMENTAL CONSERVATION
Division of Spill Prevention and Response
Prevention and Emergency Response Program

SITUATION REPORT

INCIDENT NAME: Lisburne Common Line Release

SITREP #: 6

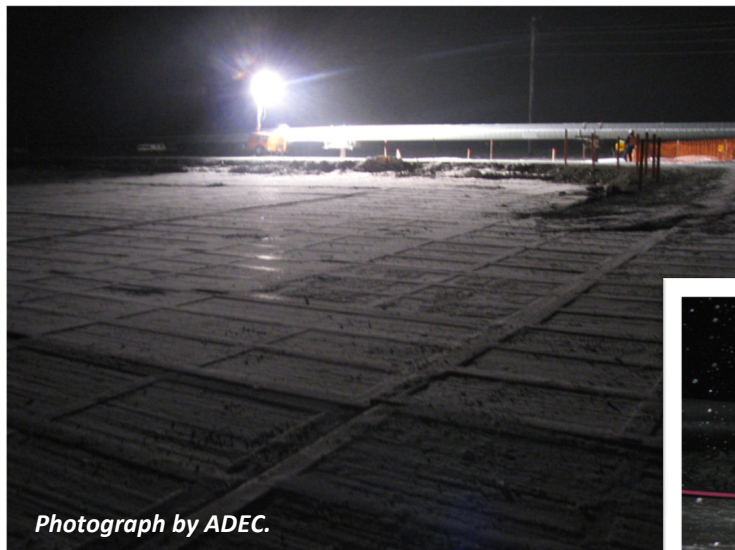
Completed staging area near the spill site.

The staging area was completed at 7:00 PM on December 3, 2009. The total completed area is 204 feet by 210 feet, composed of 201 rig mats. Two ramps were completed to allow access to the staging area from the gravel road. The staging area was designed to support work involving an access trench excavation under the pipeline and to stage equipment for mechanical removal of product from the highly contaminated area; these tactics are being reviewed by BPXA following the discovery of the liquid product.

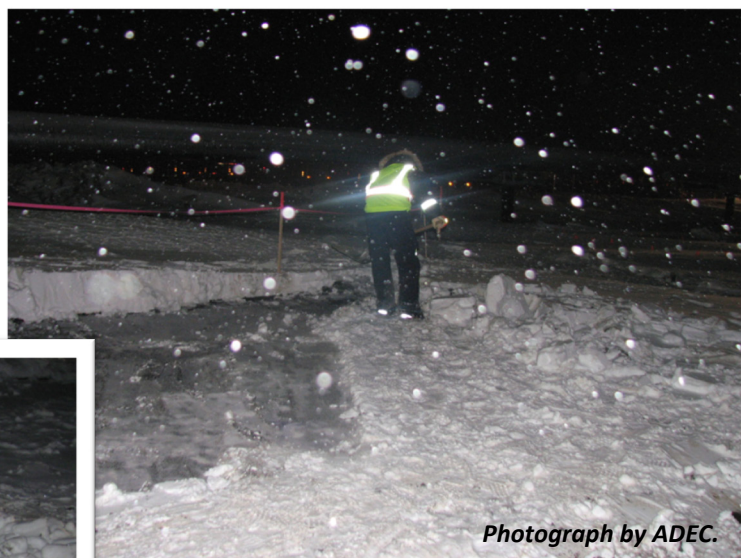
Crews collected approximately 40 cubic yards of contaminated snow from the heavily contaminated area in the South Division.

As of 6:30 AM on December 4, approximately 40 cubic yards of contaminated material was manually removed from the south side. BPXA also discovered standing liquid product under the snow during cleanup operations. There is no indication from the Forward Looking Infrared Radar (FLIR) overflights that the size of the affected area has increased. BPXA is developing new cleanup tactics for collecting standing liquid product for UC approval.

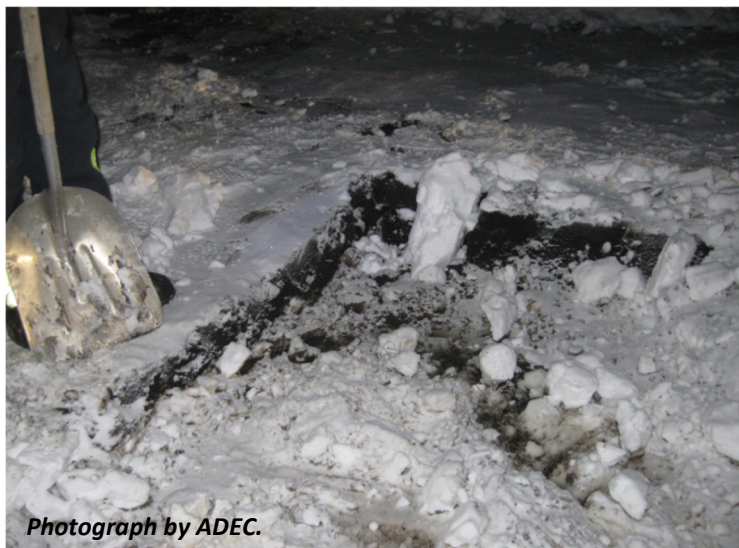
Liquid product found during cleanup operations.
