**ALASKA DEPARTMENT OF ENVIRONMENTAL CONSERVATION**  
**Division of Spill Prevention and Response**  
**Prevention and Emergency Response Program**

**SITUATION REPORT**

**INCIDENT NAME:** Lisburne Common Line Release

**SITREP #:** 7

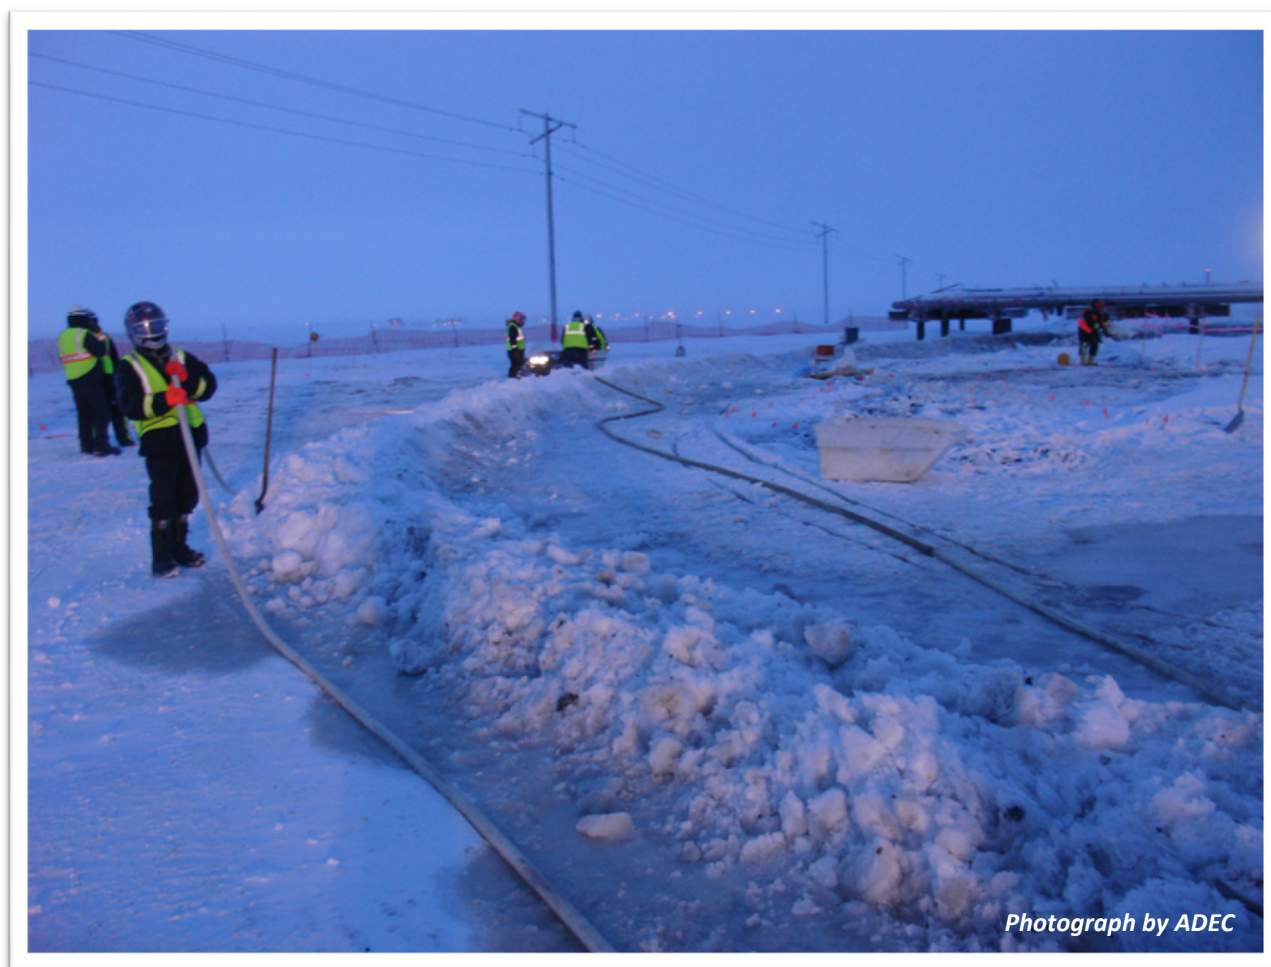
The day-shift crew building an ice berm around the spill site in preparation for steamer tactics.

Following the discovery of the less viscous, liquid product, BPXA requested and received UC approval to use steamer tactics with vacuum truck recovery for site cleanup. Planning is underway to use the steamer tactic for initial site cleanup. The steamer tactic applies localized heat to the snow and oiled material and the resultant liquid product is recovered by the vacuum truck. This tactic generates less waste and is more effective than water flushing. Work commenced at approximately 4:00 PM on December 4 to build a 3-foot ice berm around the spill site to

contain oily water. The ice berm is estimated to be completed in the early afternoon today. Steamer tactics will commence once all necessary equipment is moved to the staging area.
