**ALASKA DEPARTMENT OF ENVIRONMENTAL CONSERVATION**  
**Division of Spill Prevention and Response**  
**Prevention and Emergency Response Program**  
***SITUATION REPORT***

## **Dalton Highway Truck Rollover MP 309.5 Diesel Release**

**SITREP # 3**

**SPILL #:** 14399904301

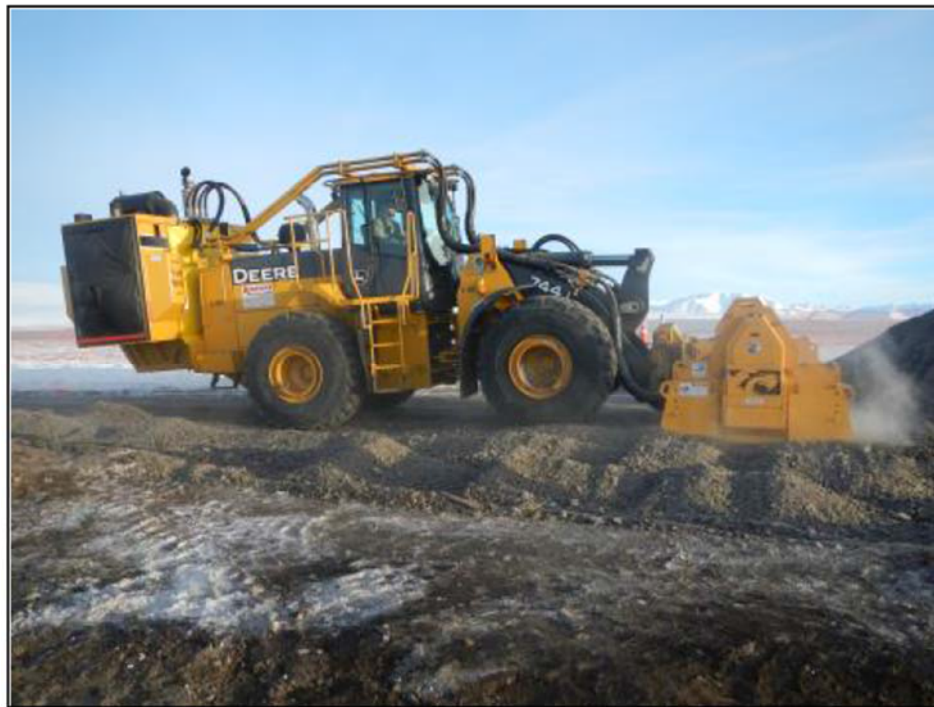
Emerald is currently using equipment to recover and stockpile the contaminated soil. A total of 680 cubic yards of contaminated soil has been removed from the spill site and transported to the AIC facility in Deadhorse, where it will be incinerated later this summer.

Loader trimmer working at the spill site. (Photo/ERM)

ADEC is working with Colville and Alyeska to develop plans for removing the remaining contamination that has impacted the buried TAPS pipeline.

**FUTURE PLANS AND RECOMMENDATIONS:** ADEC will continue to monitor the response actions and review future plans being developed to backfill the site and remove remaining contaminated soil that covers the buried pipeline.
